Published in:
Energies

Risk Assessment of Failure of Outdoor High Voltage Polluted Insulators under Combined Stresses Near Shoreline

Abstract: The aim of this paper is to investigate the various effects of climate conditions on outdoor insulators in coastal areas as a result of saline contamination under acidic and normal cold fog, determining significant electrical and physico-chemical changes on the insulator surface and considering the effect of discharge current, electric field distribution and surface roughness. To replicate similar conditions near the shoreline, experimental investigations have been carried out on insulation materials with the combined application of saline contamination and acidic or normal cold fog. The test samples included silicone rubber (SiR), ethylene propylene diene monomer (EPDM) and high-density polyethylene (HDPE), which were used as reference. The materials are of the same composition as those used in real-life outdoor high voltage insulators. All samples were aged separately in an environmental chamber for 150 h for various saline contaminations combined with acidic and normal cold fog, and were generated by means of the adopted experimental se

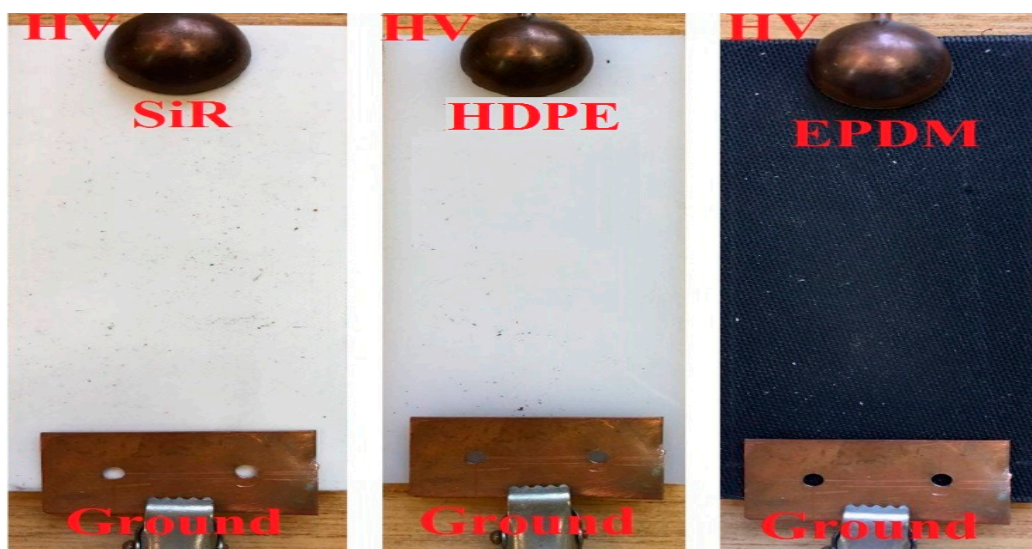
Figure 1. Experimental samples of SiR, HPDE and EPDM.

Different types of polymeric insulating material samples such as silicone rubber (SiR), high density polyethylene (HDPE) and ethylene propylene diene monomer (EPDM) with rectangular shape ($18\text{ cm} \times 4\text{ cm} \times 8\text{ cm}$) are taken with same composition as those used in real life outdoor high voltage insulators as test samples, as shown in Figure 1. Leakage current, electric field distribution and physico-chemical changes of the samples are investigated using the solid layer contamination method given in IEC-60507, under various environmental stresses in a chamber. The inclined plane test (IPT) for erosion, surface roughness and degradation and relationship to leakage current and electric field of polluted insulators, is used, which was standardized in ASTM D2303 [22] and IEC 60587 [23].

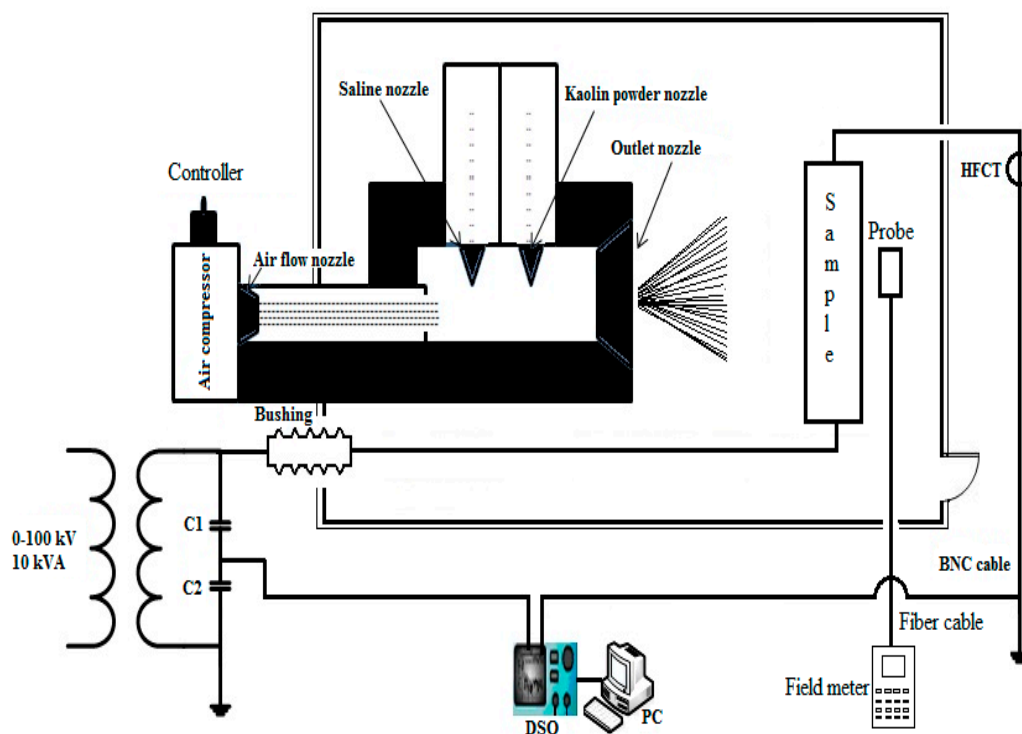
Figure 2 shows the experimental setup. In this research work the 33 kV AC test voltage was produced by a 10 kVA, 100 kV, and 50 Hz transformer. The supplied voltage can be increased manually or automatically at a rate of 1 kV/s. Acidic and normal cold fog are generated by adjusting the nozzle of the spray gun. The flow rate of fog is 2 kg/h/m^3 . The diameter of the spraying nozzle is 0.8 mm and the spraying pressure is 16.0 MPa. The conductivity of artificial contamination deposition is between 150 and 200 $\mu\text{S/cm}$ and conductivity of the acidic cold fog is between 700 and 800 $\mu\text{S/cm}$, and pH of acidic cold fog is 3.6. These values are almost the same as the acidity measured in the atmosphere near the shoreline [24]. The lowest pH value is 2.4, which occurred in Scotland in 1974 [25] indicating ultra-acidic environmental conditions. The composition and density of the ion ingredients in the preparation of acidic cold fog are shown in Table 1. This composition is used as the standard acidic fog in this research to evaluate changes in surface physico-chemical properties, leakage current and electric field for all the insulator samples.

**Figure 2.** Experimental setup.

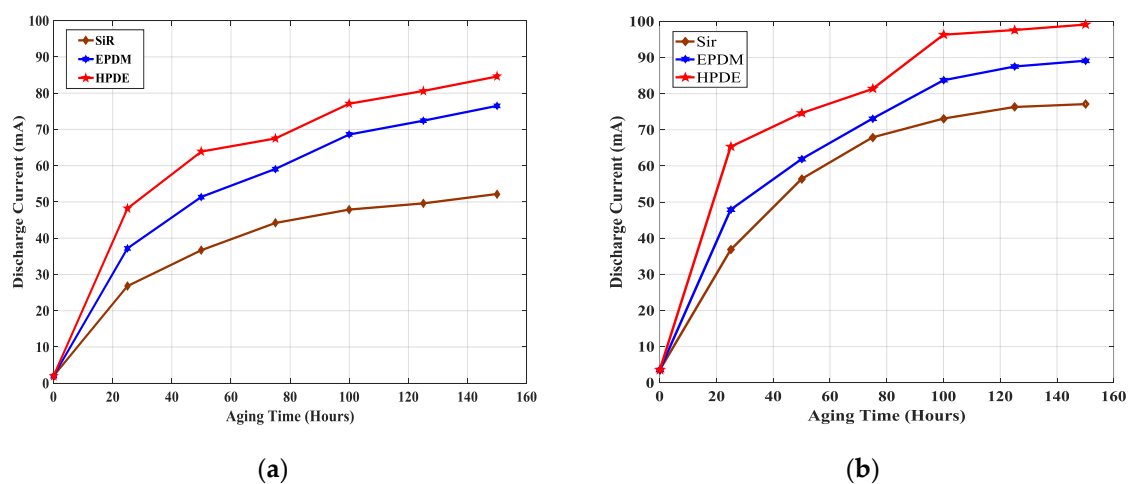
Figure 3a,b compare the discharge currents of various samples under the combined deposition of saline contamination and acidic or normal cold fog. It is observed that the discharge current increases with an increase in aging test time both in the acidic and normal cold fog and with an increase in the number of “ON” and “ON/OFF” cycles. From these figures, it is evident that the discharge current of the HDPE sample unveils a small current in “ON” when compared to the “ON/OFF” scenario, where it is too high and fails within 72 h. The EPDM sample has approximately half of this current variation both in the “ON” and “ON/OFF” scenarios over 98 h. Meanwhile, the SiR sample persists for 150 h with similar changes in discharge current in both the “ON” and “ON/OFF” scenarios. The results also indicate that the degree of surface degradation and insulator failure are not only dependent on the duration of service but are not sufficient to initiate the surface discharge phenomenon on the insulator surface. Surface degradation and failure have to be caused by a combination of electrical and environmental stresses such as saline contamination, acidic or clean cold fog and various electro-chemical reactions as well as weathering cycles and variations in the properties of the insulation materials, including SiR, HDPE and EPDM.

Figure 3. Discharge current: (a) Under combined stress of saline contamination and acid cold fog; (b) under combined stress of saline contamination and normal cold fog.

From the results it can be summarized that SiR performs better than the other materials, whereas HDPE and EPDM reveal that discharge current is about 43% and 27% higher than that of SiR. SiR gives a much lower discharge current as a result of its hydrophobic property. In addition, the effects of normal cold fog with saline contamination were also investigated for all materials. In fact, it can

be noted that the discharge current is reduced more than 31% for SiR compared to the combined application of saline and acidic cold fog conditions. The reason for this is that, in the SiR sample the Si-O bond has a high bond energy so that SiR has a high heat resistance against erosion and surface degradation. In addition, the SiR methyl group bonds, such as the C-H bond of CH₃ and Si-CH₃, are highly moisture absorbable bonds, implying the diffusion of low molecular weight (LMW) polymer liquid from the bulk to the surface. However, the weak bonds in the molecular structure of EPDM, such as the C-C and C-H bonds in ethylene (C₂) and propylene (C₃), easily degrade in acidic cold fog because of early loss of hydrophobicity. EPDM and HDPE have slow hydrophobicity restoration in harsh environments.

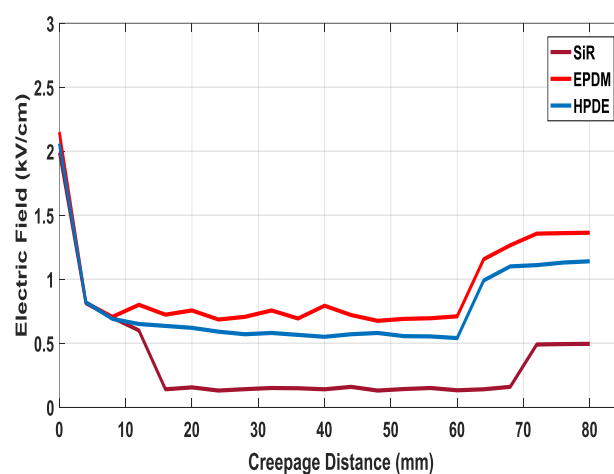
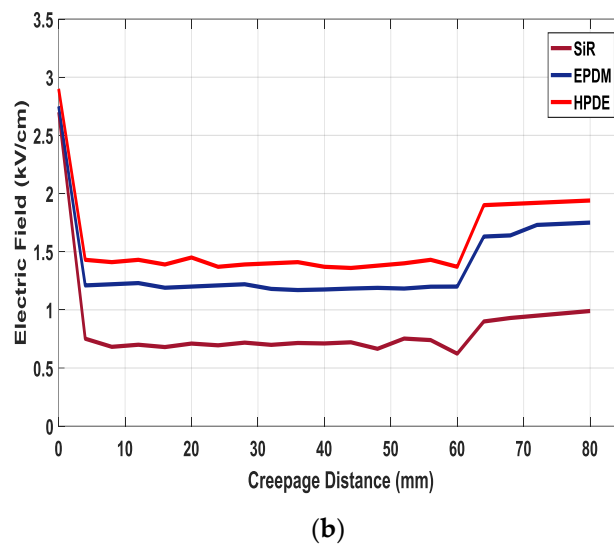
Electric field distribution along the creepage path is given in Figure 4a,b for all samples in clean and acidic cold fog respectively. Clearly, the variation of electric field among the samples results from changes in the dielectric constant. The electric field distribution for all samples is non-linear with higher amplitude near the energised than that at the grounded end. It is also observed that the field strength along the samples is completely different during combined the application of saline contamination and acidic fog as compared to saline contamination and clean cold fog. The E-field distribution was measured after 110 h of aging time. The maximum strengths for SiR, EPDM and HDPE samples in normal fog are 0.399 kV/cm, 0.401 kV/cm and 0.425 kV/cm respectively. However, these values increased to 0.533 kV/cm, 0.569 kV/cm and 0.587 kV/cm respectively after 20 min of acidic cold fog generation. The reason for this is twofold. First, relative permittivity of acidic cold fog is much higher as compared to normal cold fog, which enhances the field strength in the surrounding air. Second, water droplets deform in the direction of the field, making their curvature smaller and increasing the field further.

Figure 4. E-field distribution along creepage distance: (a) During combined stress of saline contamination and acidic cold fog; (b) during combined stress of saline contamination and normal cold fog.

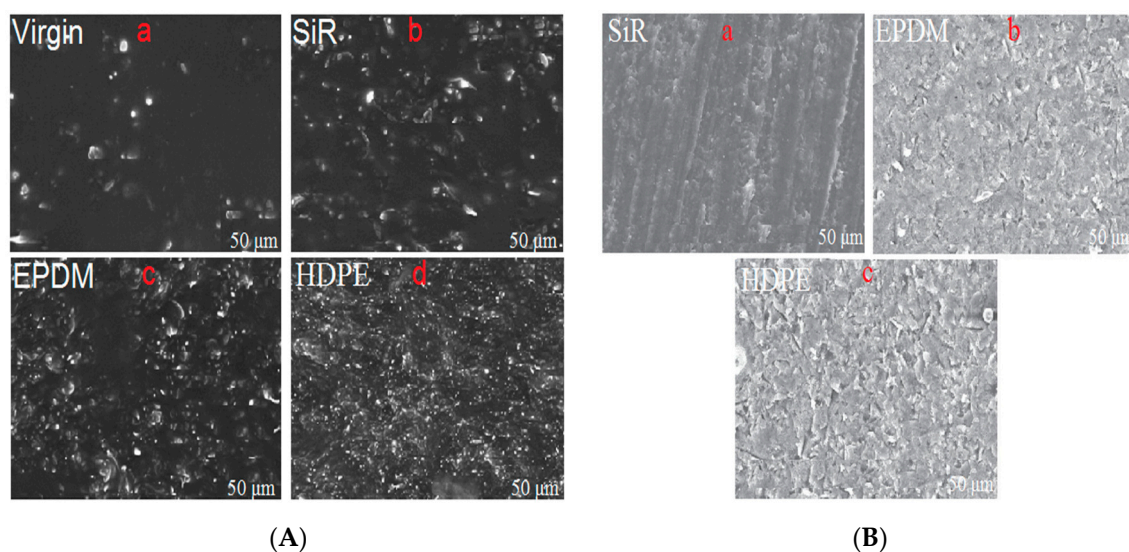
A Scanning Electron Microscope (SEM) analysis was undertaken to obtain information about the specimens' surface structures and composition. Morphological and topological changes in the samples before and after the acidic and clean cold fog tests are shown in Figure 7A,B. Material properties have been observed after 150 h of aging for both acidic and clean cold fog conditions. Figure 7A shows the virgin sample before the treatment at a magnification range of 50 μm , it shows no dents, cracks or surface roughness and degradation. On the other hand, cracks and significant dents can be identified after 150 h of aging for all materials, especially on more exposed parts, such as those where the flow of leakage current was higher during the acidic than the clean cold fog application, as shown in Figure 7B. It was found that the surface morphology changes of the sample treated in acidic cold fog are different from those in clean cold fog. As for Figure 7A, no major cracks and dents were found in the clean cold fog samples except for some parts showing minor cracks and dents. This may be because of smaller discharge intensity in clean cold fog. The material treatment for the acidic fog was more served than that for clean cold fog as a result of high intensity of discharge activities. The experimental results discussed above reveal that acidic cold fog exposure has more severe degradation effects on insulation materials than clean cold fog exposure. After aging in acidic cold fog, the surface becomes rough with a number of dents and cracks and a decrease in the hydrophobicity. Moreover, the surface of EPDM and HDPE is damaged severely when compared to SiR, as the Si-O bond has high bond energy resulting in a high heat resistance against discharge and degradation.

Figure 7. SEM picture of insulator surface: (A) Surface aged in acidic cold fog for 150 h, (a) Virgin; (b) SiR; (c) EPDM; (d) HDPE; (B) surface aged in clean cold fog for 150 h, (a) SiR; (b) EPDM; (c) HDPE.
